Counting the cost of the 'free' bridge

AIA Bulletin 13/2 (the last one) carried a short piece on the testing-to-destruction of an 18th century masonry canal bridge near Shrewsbury and how it refused to concede defeat until a load of 215 tons had been applied. Coincidentally, and rather ironically in view of its close proximity to AIA headquarters at Ironbridge, the Jackfield 'free-bridge' only a few hundred yards from its distinguished neighbour, **the Iron bridge**, is beginning to show its age and a recently applied weight restriction is causing minor chaos, particularly to the administration of Ironbridge Gorge Museum coach excursions. **John Powell writes:**

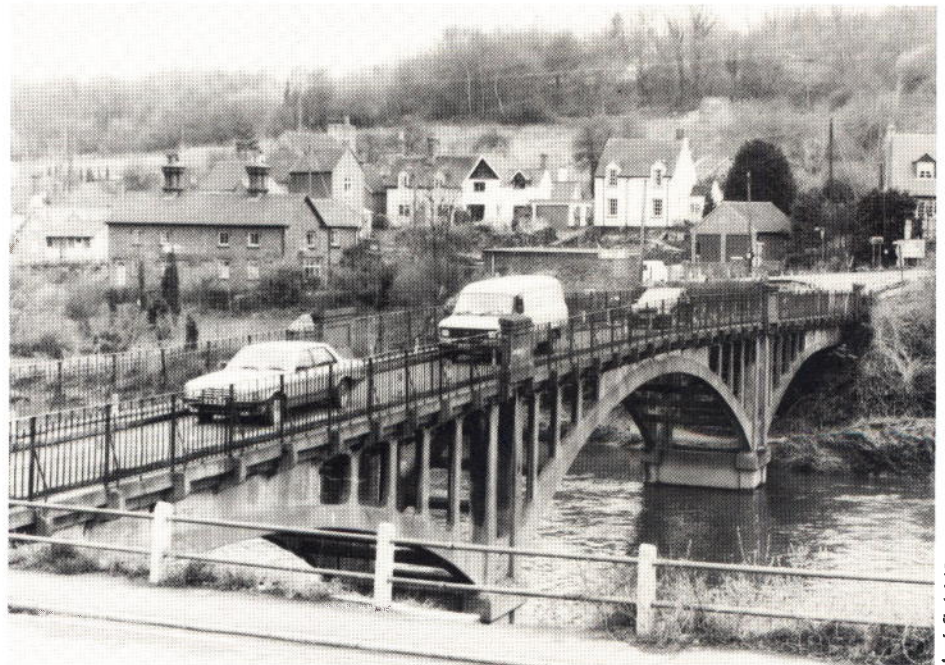
Jackfield 'free bridge' today

Editorial comment: Obviously Jackfield bridge was not designed to be the strongest bridge in the world for on 19th June 1909, after it had been commissioned, the Wellington Journal reported that the official test load had consisted of a 14 ton steam roller which was in fact 2 tons heavier than had been calculated for. Nevertheless: this relatively early failure seems unusual in view of its ancestry for it was a Mouchel-Hennebique reinforced concrete structure built in an era when this named

Of course there were failures and the study of defects, resulted in repair methods being evolved. Possibly the Jackfield bridge came in this category and maybe the repairs carried out did not completely rectify the faults which have since become more serious.
