INDUSTRIAL ARCHAEOLOGY NEWS

122
AUTUMN
2002

Llythyrdy Smithy, Pentrebach, Powys

In October 2001 a contracted archaeological desk-top study, photographic recording and building survey was undertaken on the site of a former village smithy which to be converted for domestic use. Cartographic evidence showed a building occupying the site of the smithy in 1819, which is shown clearly as a three-compartment building in 1905. The dry stone walled structure suggests a possible eighteenth century origin. The smithy is a rare example of small rural industry and includes a forge hearth that has been left untouched since it went out of use in the latter half of the twentieth century.

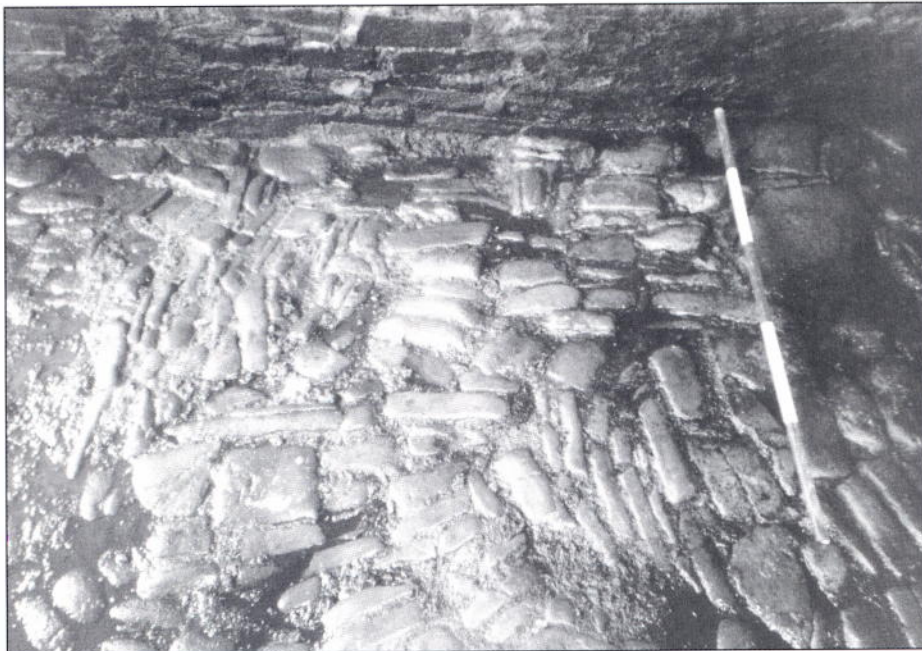
The cobbled floor. Scale: 1m

Clearance of soil and ash revealed an irregular cobblestone surface which appears to extend over the entire floor area. The floor is composed of waterworn smooth cobbles with intermittent square and rectangular stones. In front of the hearth on the east side an irregular shaped filled in hole may indicate the location of a hoist. There was no evidence to suggest the site of the anvil or the water trough for cooling metals and tools.
