INDUSTRIAL ARCHAEOLOGY NEWS

122
AUTUMN
2002

Llythyrdy Smithy, Pentrebach, Powys

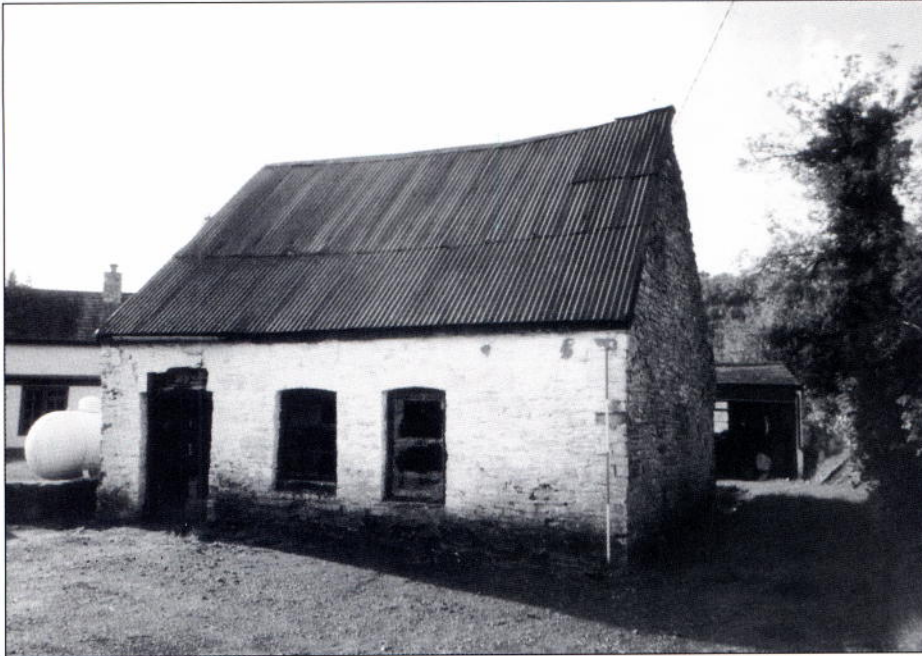
The roadside smithy, viewed from the north-east, beneath a corrugated roof

The smithy forms a single storey building measuring 6.9m by 6m wide externally, fronting the west side of the road. The north and south gables rise to c5m at the apex and the walls are 0.6m thick on all sides. The building is constructed of irregularly coursed and unmortared local linear-bedded sandstone. The fabric shows signs of past lime wash and more recent patches of concrete rendered repair work. The east and west long walls stand c2m above the external ground level, but the floor level inside is 0.4m lower because the road has been raised.

The current roof is covered with corrugated iron sheets, but a former stone tiled roof is suggested by finds on the site of two sandstone roof tiles with nail holes. The roof is supported by a central through purlin tie beam truss with collar beam constructed in oak. Joiner's marks in the form of three parallel lines were located on the

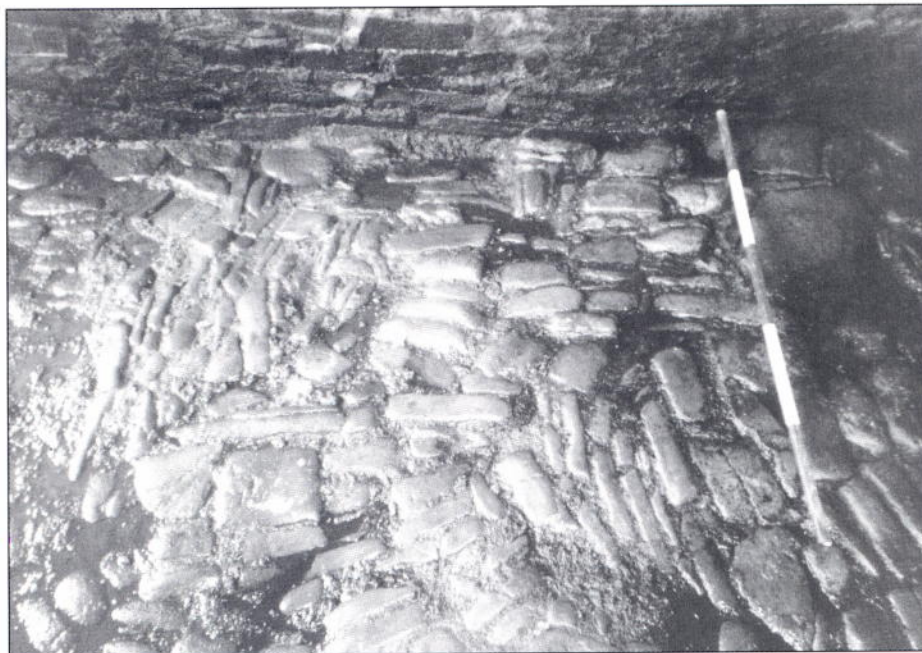
The cobbled floor. Scale: 1m

Clearance of soil and ash revealed an irregular cobblestone surface which appears to extend over the entire floor area. The floor is composed of waterworn smooth cobbles with intermittent square and rectangular stones. In front of the hearth on the east side an irregular shaped filled in hole may indicate the location of a hoist. There was no evidence to suggest the site of the anvil or the water trough for cooling metals and tools.
